FIVE-YEAR REVIEW REPORT

FOR
PHOENIX-GOODYEAR AIRPORT (SOUTH)
SUPERFUND SITE
GOODYEAR, ARIZONA

September 2005

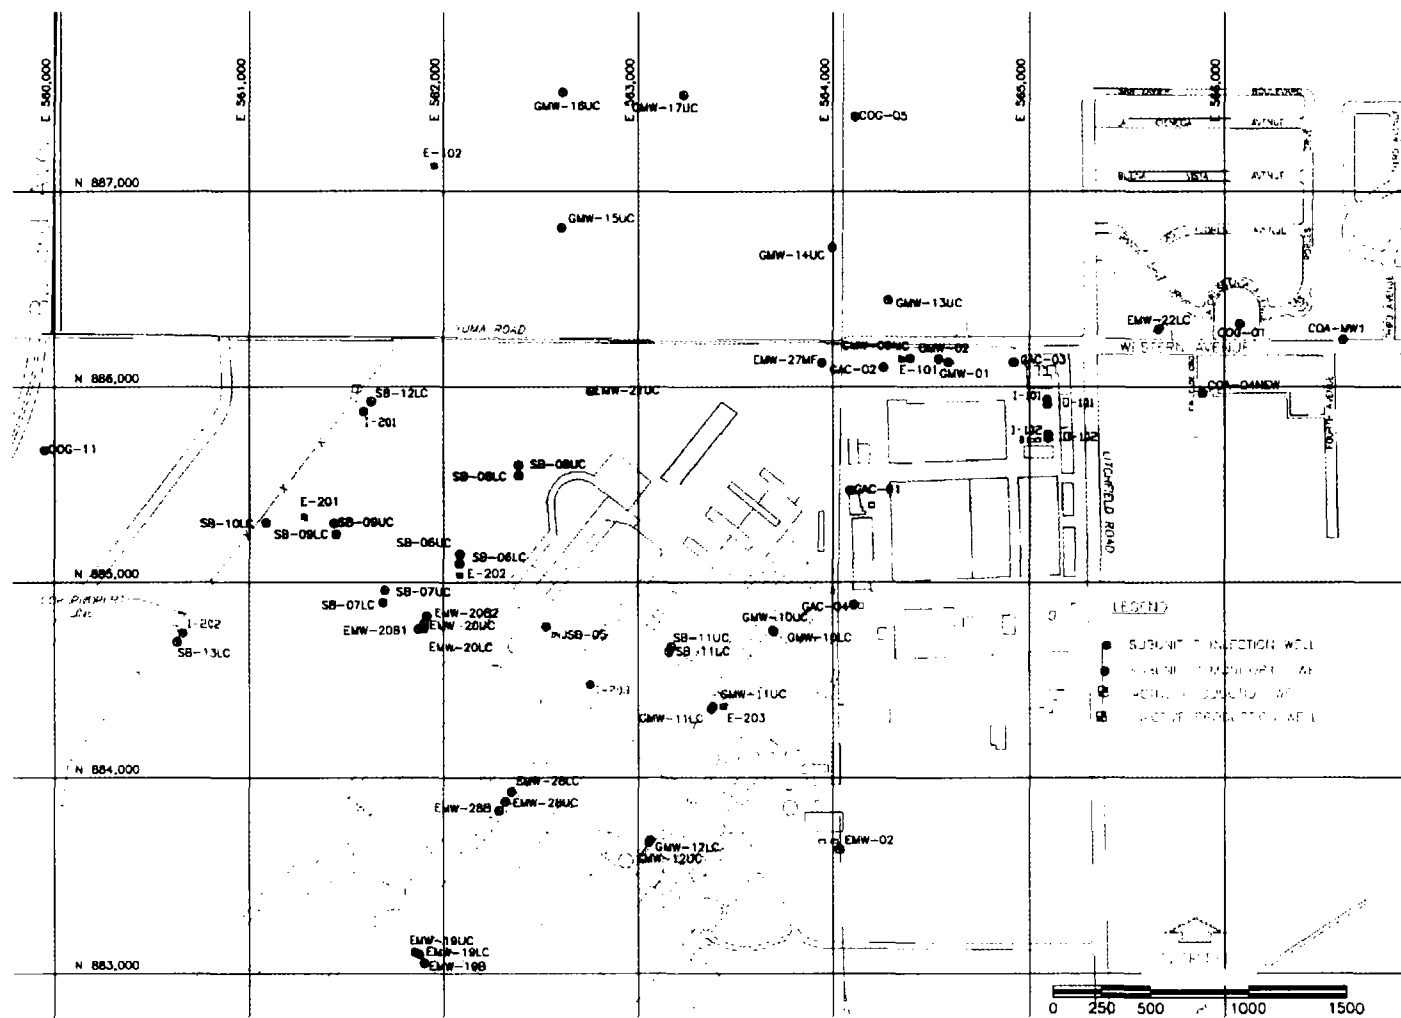
Figure 3-1
Area Map Showing Subunit C Wells
Source: Sharp and Associates 2005c

Groundwater is the primary source of water for all domestic, industrial and irrigation water in the area. Numerous production wells are located within one-half mile of the site. These wells are for municipal uses by the City of Goodyear as well as agricultural uses by various property owners. See Figure 3-1 for the locations of nearby production wells.

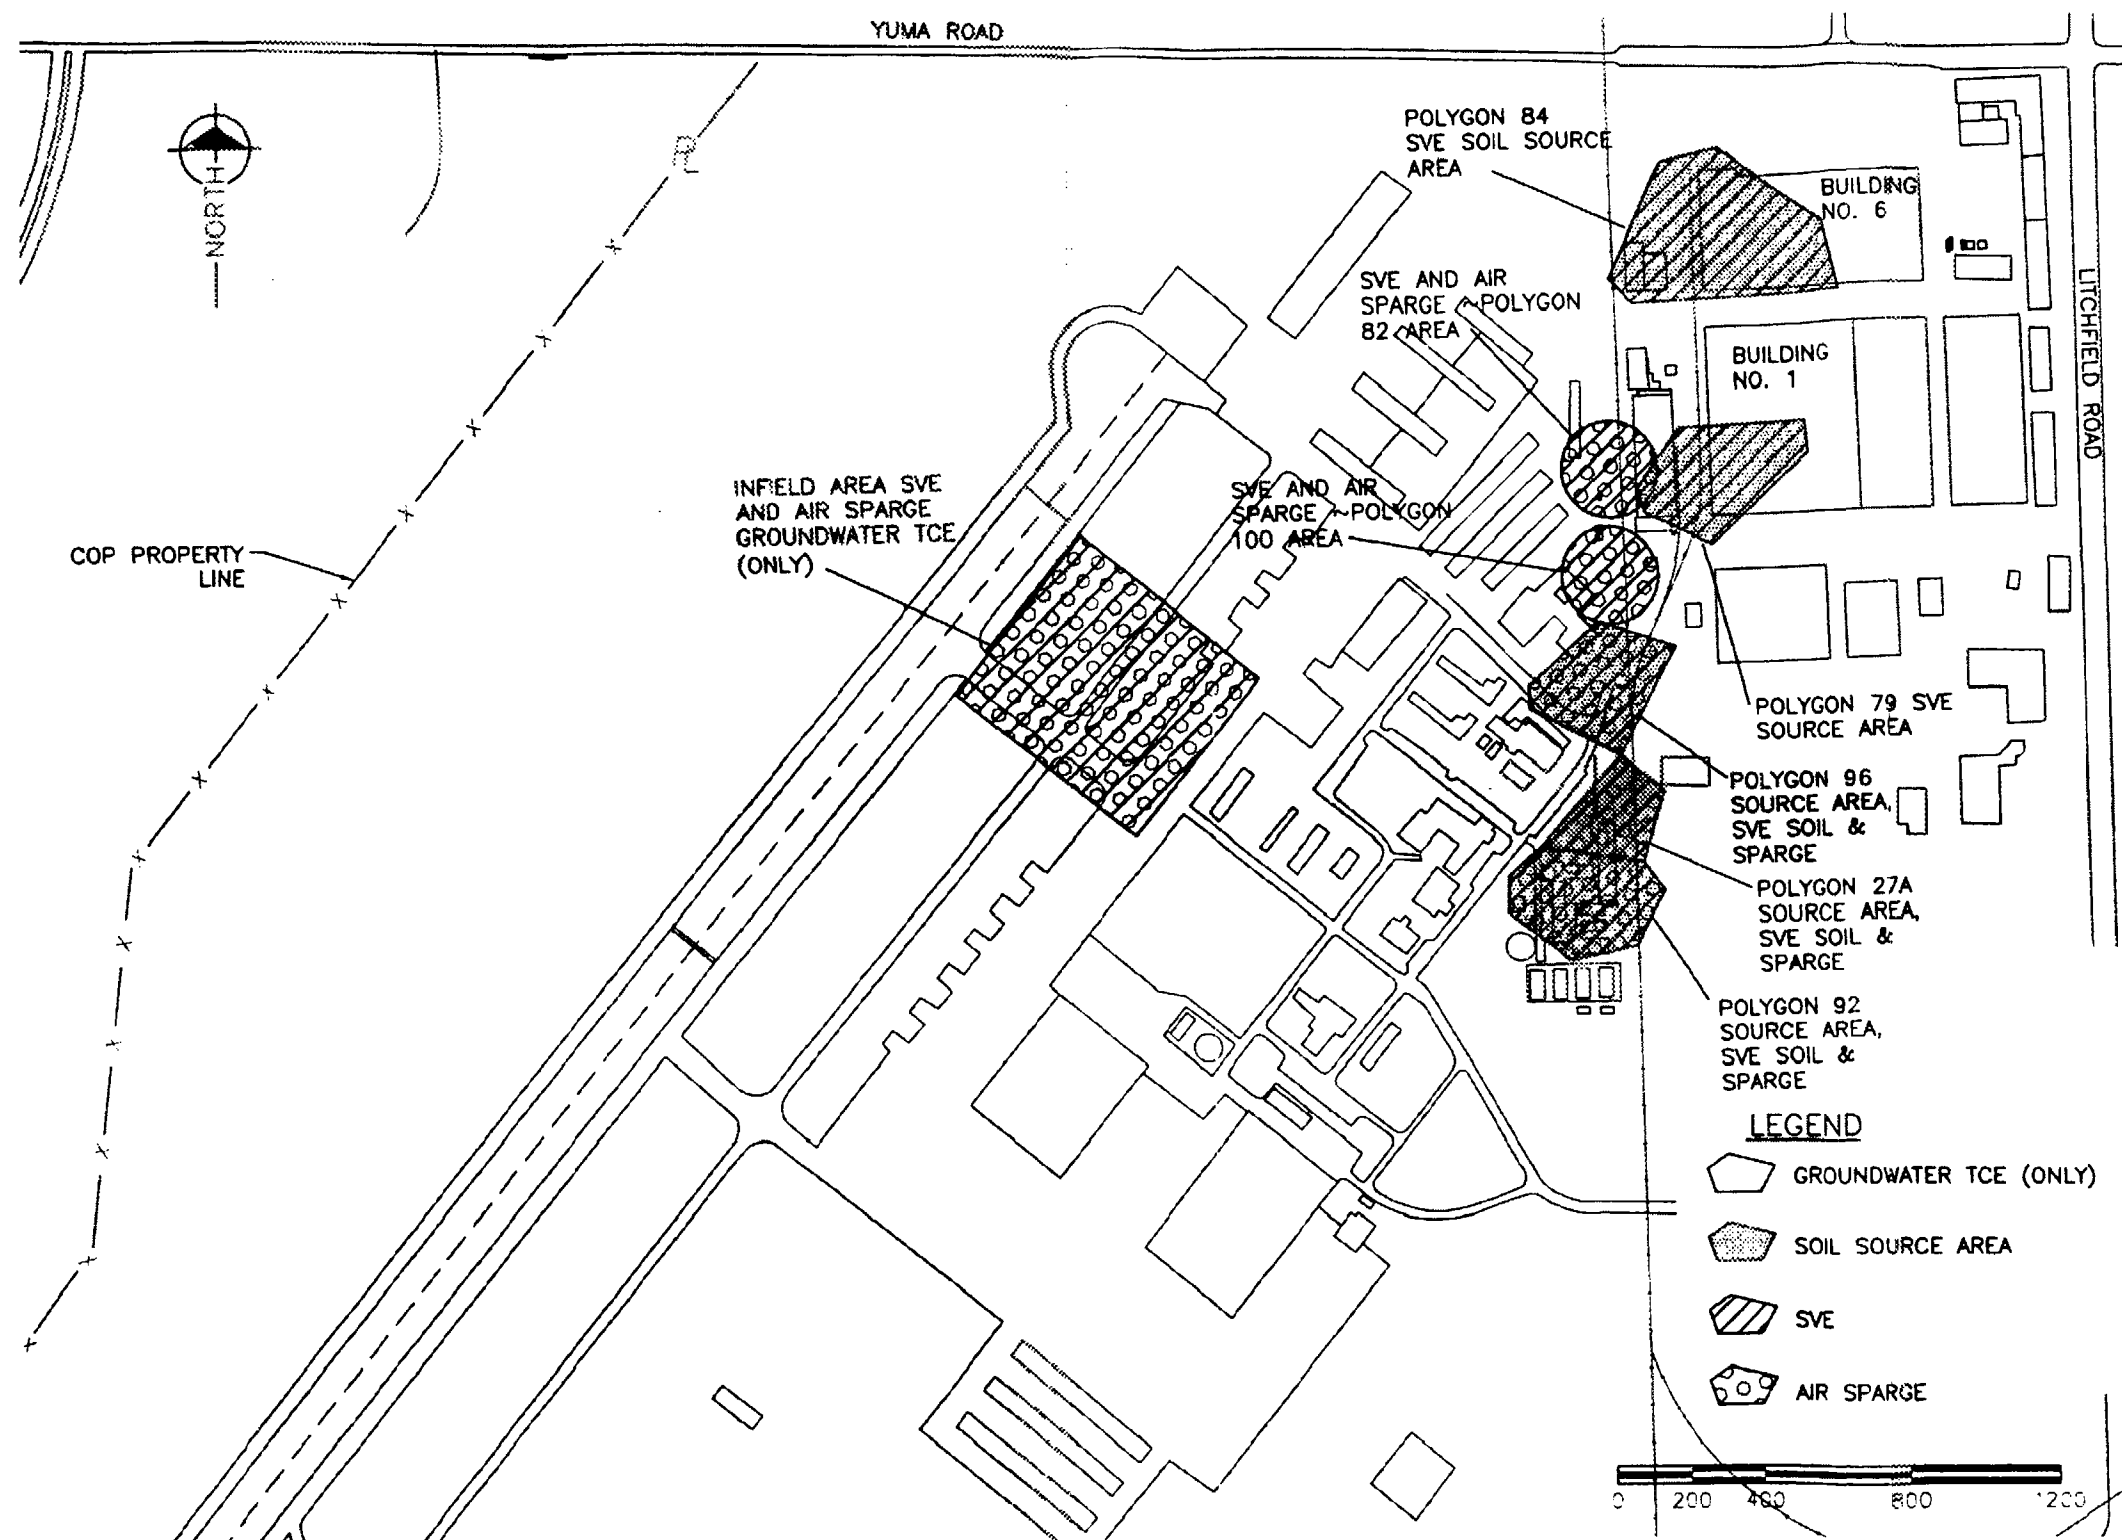
Figure 4-1
 Soil Vapor Extraction and Air Sparging Locations
 Phoenix Goodyear Airport (South)
 Source: Sharp and Associates 2005a

Several efforts were made to determine which areas of the site would be most suited for SVE treatment. All efforts involved using soil or soil gas analytical data from different polygonal areas of the site to predict the effect on TCE concentrations in groundwater below the polygons. In May 1992, a conservative total mass dissolution test was run on 143 polygons, of which 80 polygons failed, that is, were predicted to impact groundwater with TCE concentrations greater than 5 µg/L. VLEACH and a mixing cell model were then run on these 80 polygons, resulting in 14 polygons failing. Additional field data was collected in 1992 and 1993. Additional modeling took place, which resulted in selection of five polygons which required remediation using SVE. The polygon numbers were 79, 84, 96, 92 and 27a (See Figure 4-1).

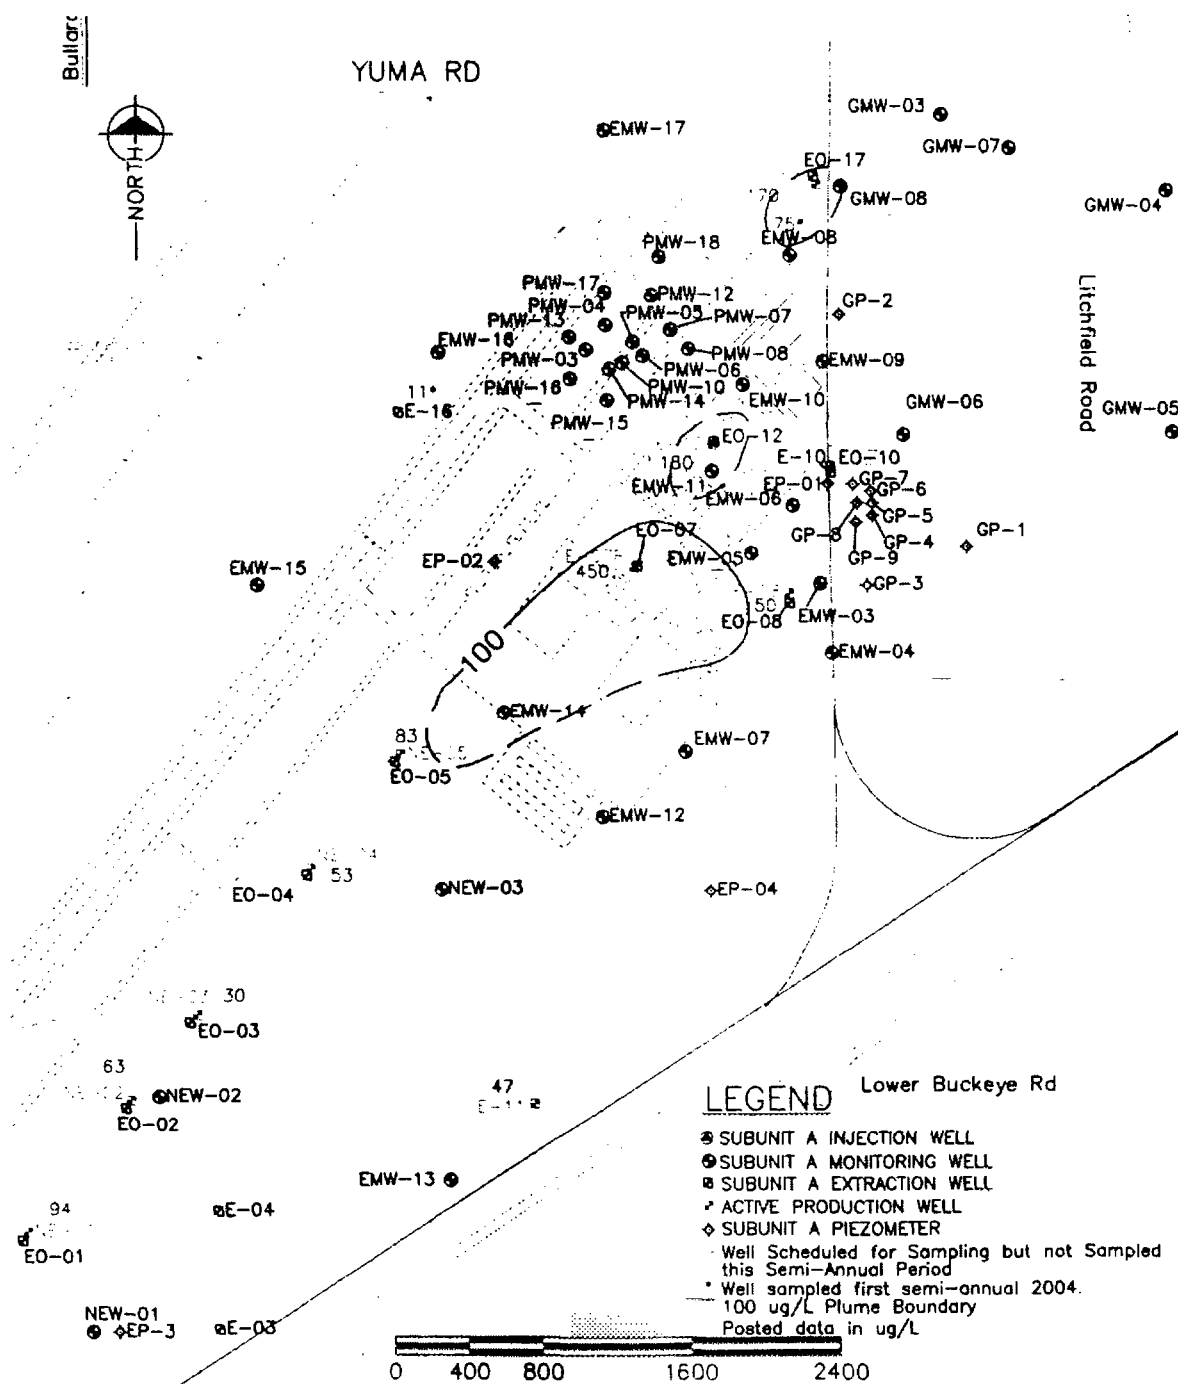
Figure 4-5
Chromium in Subunit A, 2004
Phoenix Goodyear Airport (South)

The 1987 ROD allowed for blending of extracted groundwater to meet the cleanup level for chromium as an interim measure. ESD #3 addressed removal of chromium from Subunit A groundwater through the addition of a metal adsorption wellhead treatment system. A chromium treatment system for groundwater was in operation between 1995 and 2001 at well E-17, but the system encountered many operational difficulties and has not been in use since 2001. As a result, chromium currently passes through the groundwater treatment system and is reinjected into the aquifer. Subunit A extraction wells containing chromium above the MCL of 100 µg/L are E-07R, E-12 and E-17, with concentrations of 450, 180 and 170 µg/L, respectively, in the second half of 2004 (Sharp and Associates, 2005b). The distribution of chromium in Subunit A is shown in Figure 4-5.

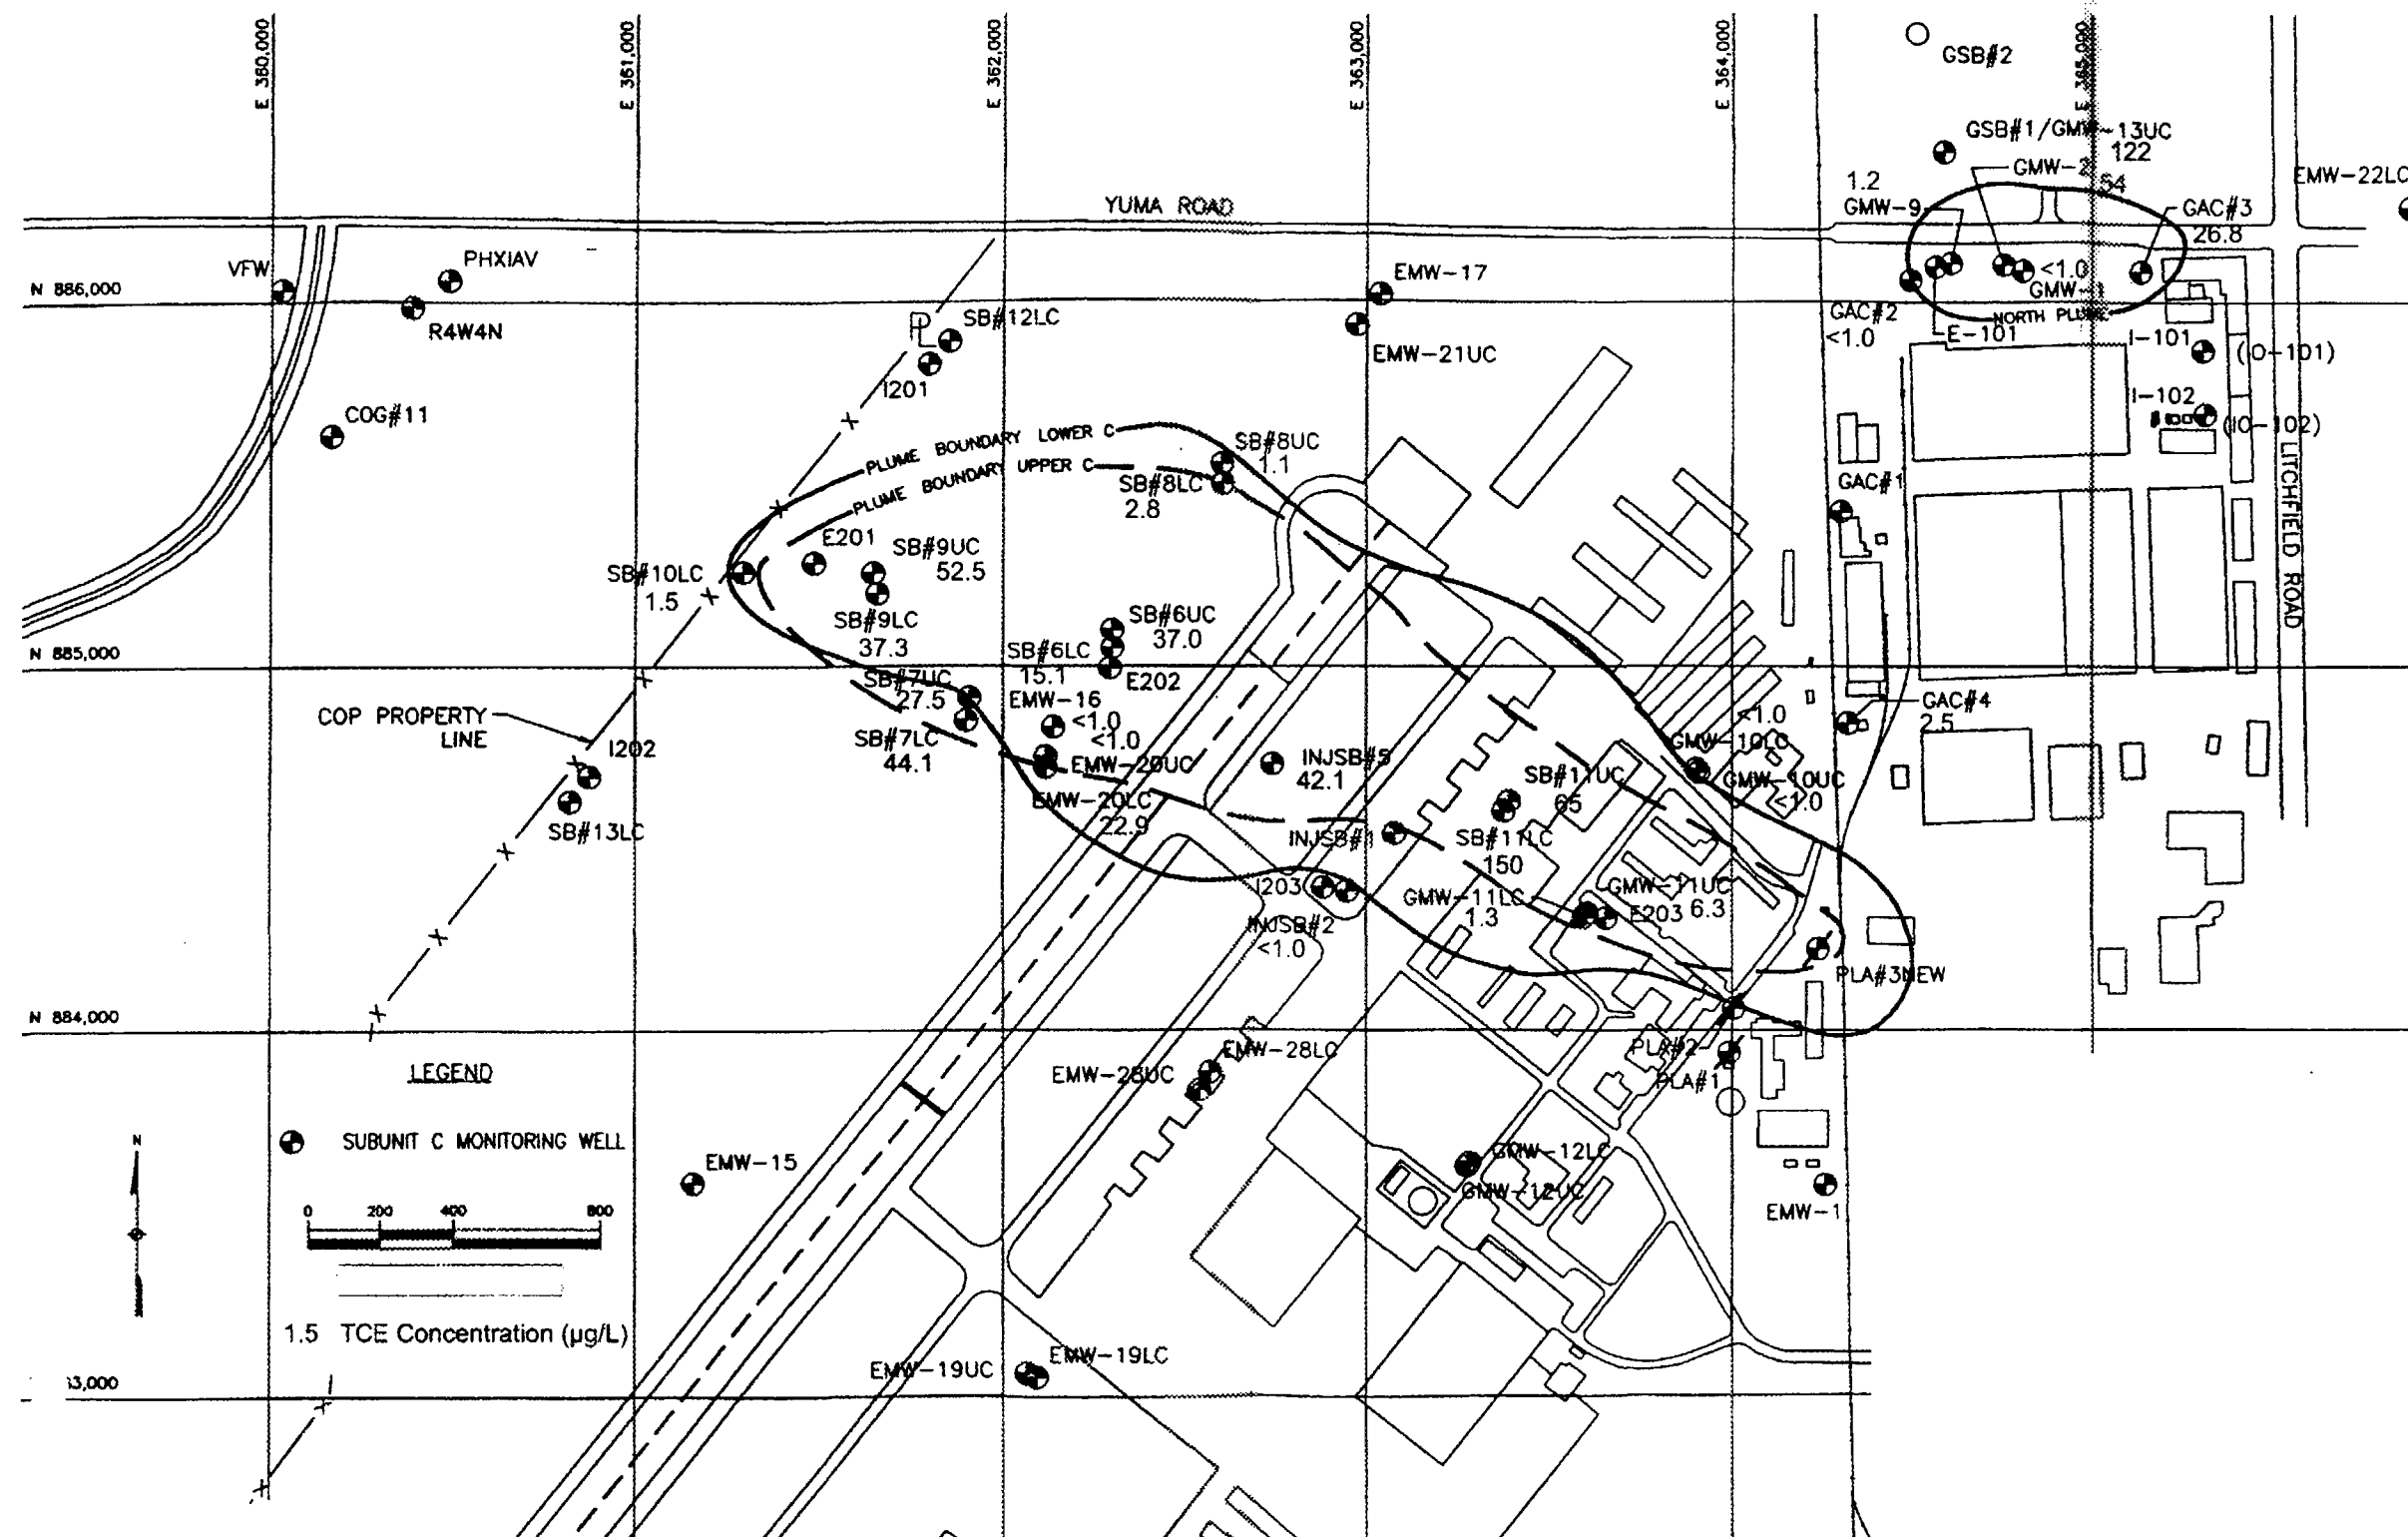
Figure 4-6
TCE Concentrations in Subunit C, 1995
Phoenix Goodyear Airport (South)
Source: Sharp and Associates 1995a, Sharp and Associates 2005b

There were originally three zones of contamination within Subunit C: the southern plume, the central plume and the northern plume (See Figure 4-6). Contamination is believed to have entered Subunit C from Subunit A through conduit wells. The known conduit wells were investigated in 1992 and either abandoned or repaired (Sharp and Associates, 1994b). Initially each of the three plumes has a separate extraction and treatment system. The northern system operated between February 1994 and December 2004 and consisted of two extraction wells, one liquid-phase granular activated carbon system and one injection well. The central system consisted of one extraction well and a reverse osmosis unit and operated for about 3 years. The southern system began operation in September 1994 and is still in operation.

The Southern Subunit C groundwater treatment system has been effective in removing TCE mass and reducing the size of the plume, as shown in Figures 4-6 and 4-7. Concentrations of TCE in the southern Subunit C plume ranged as high as 200 µg/L in the airport infield area (Sharp and Associates, 1994b). In 2004, TCE concentrations in the vicinity of the southern plume ranged from non-detect to 55 µg/L (Sharp and Associates, 2005b).
